Manhole Inspection Summary

Manhole # S63M__001MH

Insp Date: **4/25/08 11:00 AM**

Location Address: **5501 O'Donnell St.**

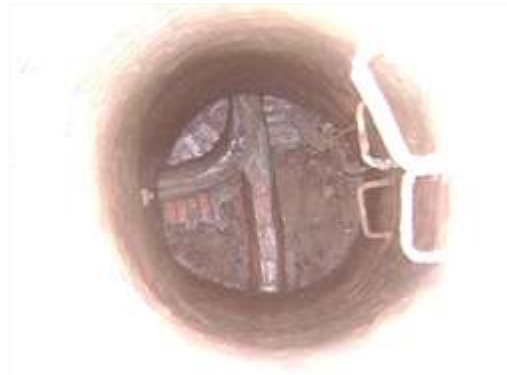
Top View

Condition: ☐ Sound ☐ Cracked ☐ Root Intrusion ☒ **Loose Brick** ☒ **Deteriorated**

Infiltration: ☐ None ☒ **Joint** ☐ Cracks ☒ **Mortar** ☐ Roots ☐ Wall
